Manhole Inspection Summary

Manhole # S63A__005MH

Insp Date: **5/23/08 7:35 AM**

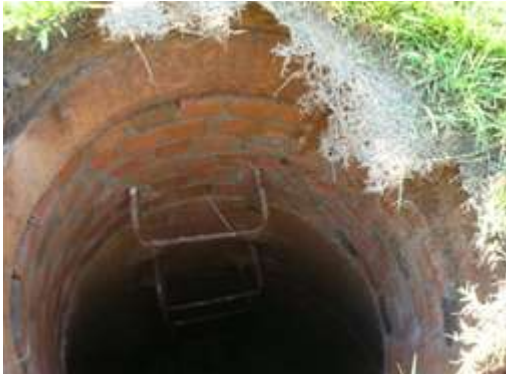
Defect 1

Infiltration: ☐ None ☐ Joint ☐ Cracks ☐ Mortar ☐ Roots ☒ **Wall**

INFILTARTION

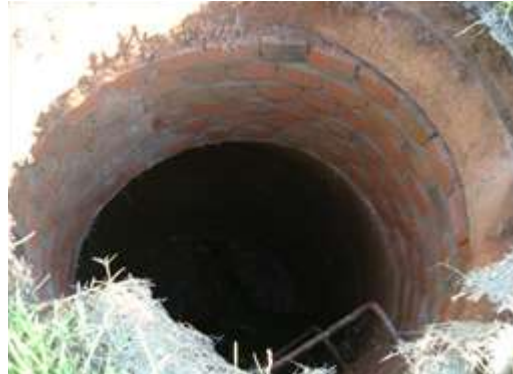
Defect 2

frame leaks

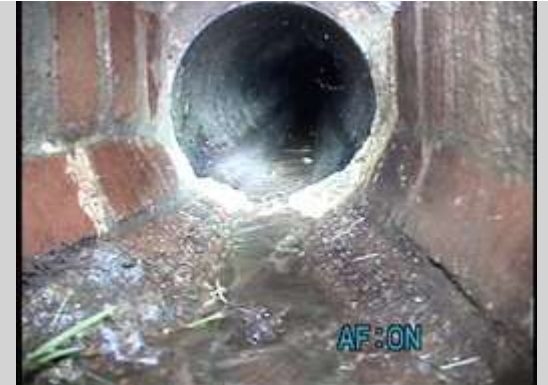
12 O'Clock Outflow

8 in. Circular Gravity Sewer
Pipe Out @ 12 O'Clock

Pipe Height: **8.4** (in.) Rod and Bar (Angled)
Pipe Material: **Clay** ☐ Pipe Lined
Invert Depth: **10.05** (ft.) Flow Characteristics: **Fast**
Deposits: ☒ None ☐ Mud ☐ Sludge ☐ Debris ☐ Grease
Silt Depth: (in.) Deposits Extent:
Infiltration: **None** Pipe Seal Cond: **Sound**

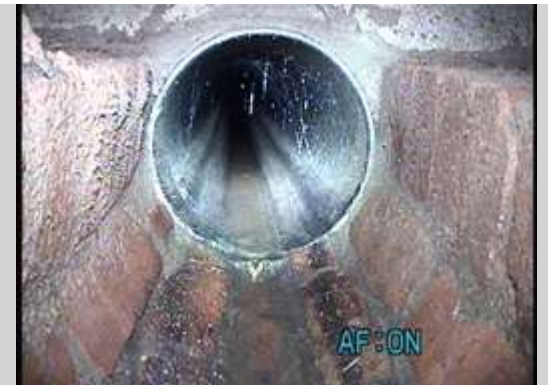
6 O'Clock Inflow

8 in. Circular Gravity Sewer
Pipe In @ 6 O'Clock

Pipe Height: **8.4** (in.) Rod and Bar (Angled)
Pipe Material: **Clay** ☐ Pipe Lined
Invert Depth: **9.50** (ft.) Flow Characteristics: **Fast**
Deposits: ☒ None ☐ Mud ☐ Sludge ☐ Debris ☐ Grease
Silt Depth: (in.) Deposits Extent:
Infiltration: **None** Pipe Seal Cond: **Sound**

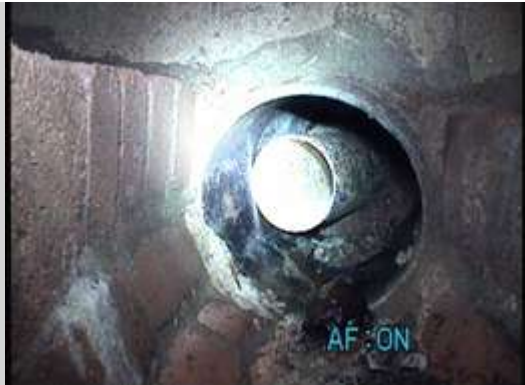
9 O'Clock Inflow

Pipe Height: **8.4** (in.) Rod and Bar (Angled)

Invert Depth: **9.60** (ft.) Flow Characteristics: **None**

Infiltration: **None**

Pipe Seal Cond: **Sound**
